A Comprehensive Review of Flexible Pavement Failures, Improvement Methods and its Disadvantages

Sadia Tasnim^{1,a*}, Faiz Uddin Ahmed Shaikh^{1,b}, Prabir Sarker^{1,c} Shu Ing Doh^{1,d*} and Ja'far A. Aldiabat Albtoosh^{3,e}

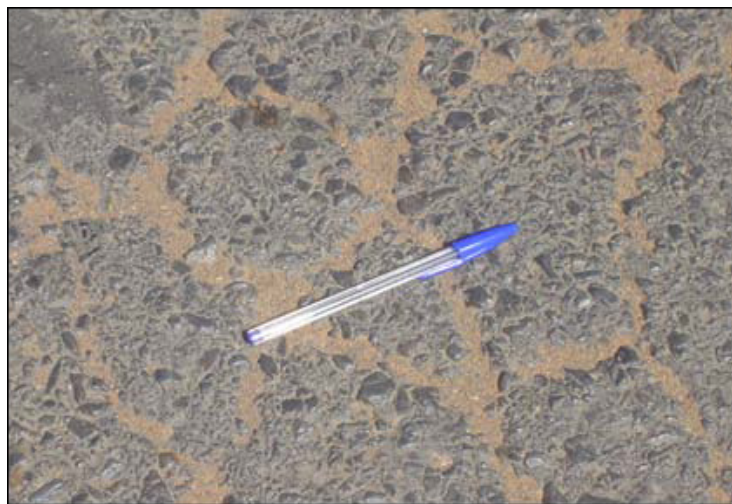
Fig. 3 Alligator cracking of high severe level [5]

Cracking occurs due to a variety of reasons. Flexible pavement cracking comes in wide range of patterns and are resulted from a large number of causes, but generally occurs due to ageing of the surface, environmental condition or fatigue failure of the pavement [5]. The main problem with crack is that, it allows moisture which accumulates on the pavement to enter into the pavement sub-bases, resulting deterioration of the pavement at a faster rate [5]. Figure 3 and 4, shows image of cracking in flexible pavement. Potholes in general are the final result of alligator cracking. Figure 5, shows image of water ponding on potholes. As the alligator crack becomes severe, small block of pavement are displaced causing hole to remain in the pavement which is known as potholes [5]. Rutting is a major problem encountered in many flexible pavement systems. One particular reason for rutting is due to the thickness of the pavement which is not designed to carry big number of traffic and heavy axel loads [11]. One main reason for flexible pavement failure is excessive moisture [5]. Apart from that, sudden increase in traffic loading is another reason for pavement deterioration [10]. Temperature variation ranging from 50 °C to below zero conditions leads to bleeding and cracking. Besides that, poor drainage system and poor sub-grade soils are also responsible for pavement deterioration.

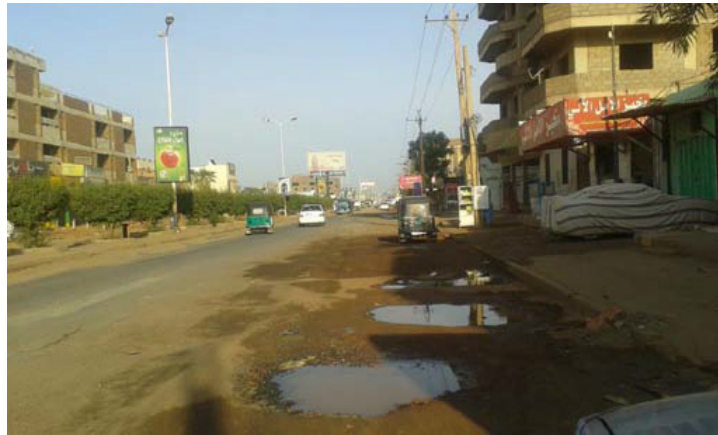
Fig. 5 Water Ponding on Potholes [5]

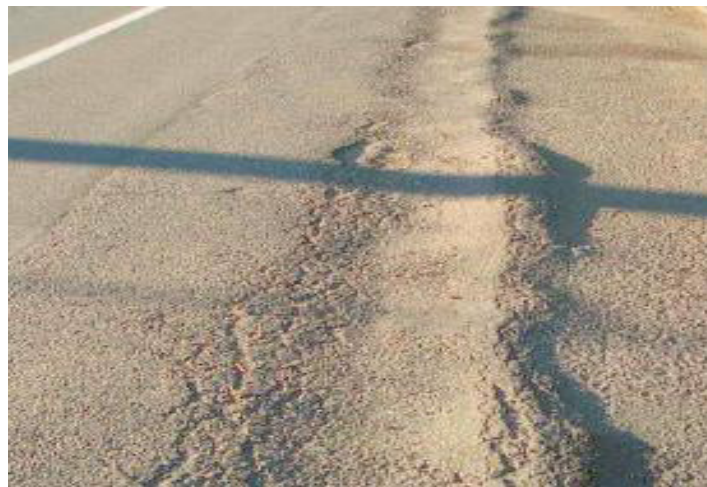
Fig. 6 Rutting in Flexible pavement [14]

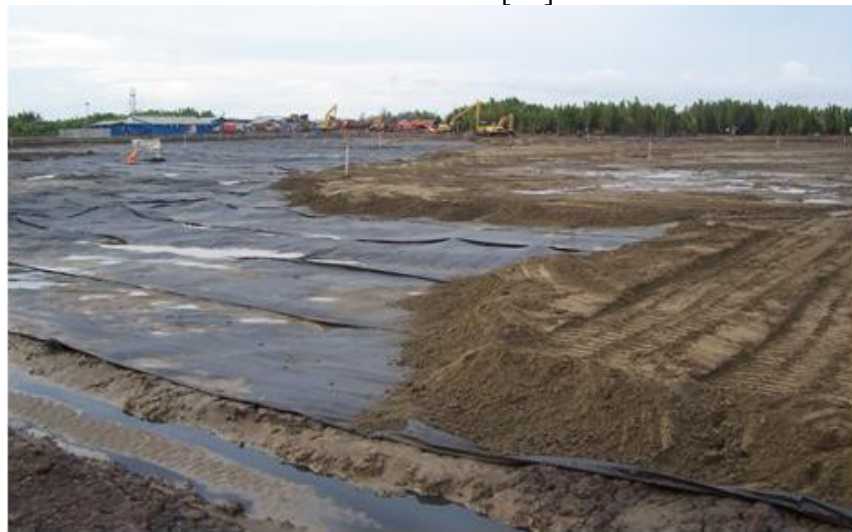
Fig. 9 The use of geo-textile for separation between foundation soils and the backfill material [48]

The failure of flexible pavement commonly occurs due to sub-grade failure, sub-base or base course failure or wearing course failure [7, 24]. Figure 8 to 10 demonstrates the sub-grade failure, wearing course and base course failure of flexible pavement. In order to reduce the rate of this failure, different techniques are currently applied. One common technique used in order to reduce the wearing course failure of flexible pavement is through maintenance [19]. The maintenance would consist of routine and periodic activities. Routine maintenance would include sanding, local sealing, crack sealing, filling depression, surface patching and base patching. Periodic activities would consist of surface dressing, fog spray, pavement overlaying and slurry seal.
